Asset and Enterprise Committee

Old House

The Old House, Brentwood

Conservation Statement

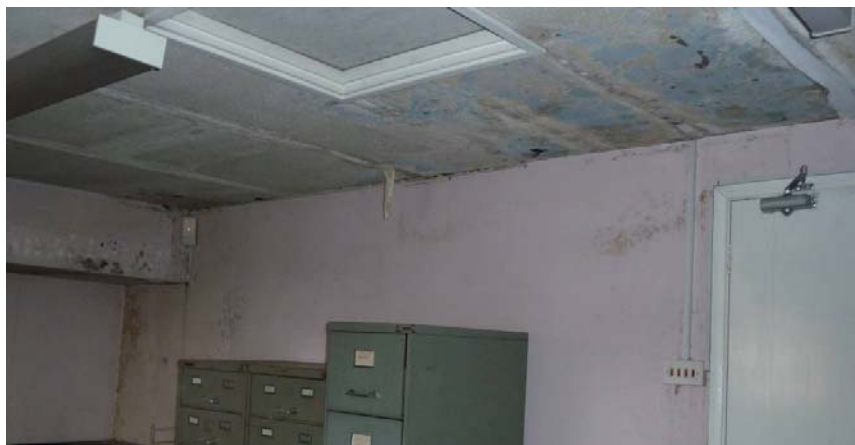
The ceiling has suffered damage where the valley gutter has leaked subsequent to the theft of lead from the roof.

Talking newspaper (West) – serious damp to ceiling

The recent theft of lead from the roof has caused water to enter parts of the first floor and led to an outbreak of mould growth. This will require roof repairs, stripping out of damaged finishes, and a period of drying time before reinstatement. There is also a damp area on the wall of room 6 on the ground floor, the cause of which is unclear. Repairs have been carried out at roof level, but should also be carried out internally as a matter of urgency.

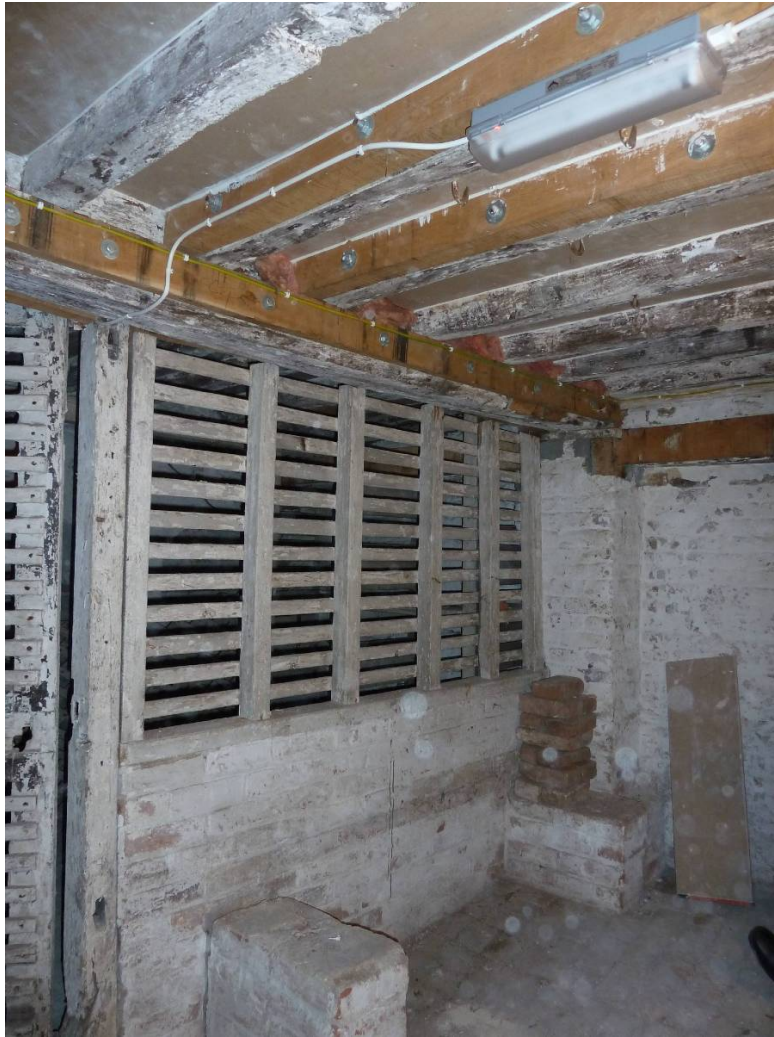
In the cellar there are narrow section joists and a bridging joist exposed, a number of which, including the bridging joist, have been repaired by having softwood timber bolted to the failing members. The main bridging joist shows sign of decay although it looks and feels dry. The ends of the common joists have been picked up by bolting a timber to the bridging joist.

Left: Ventilated storage area - bridging and joists visible with repairs

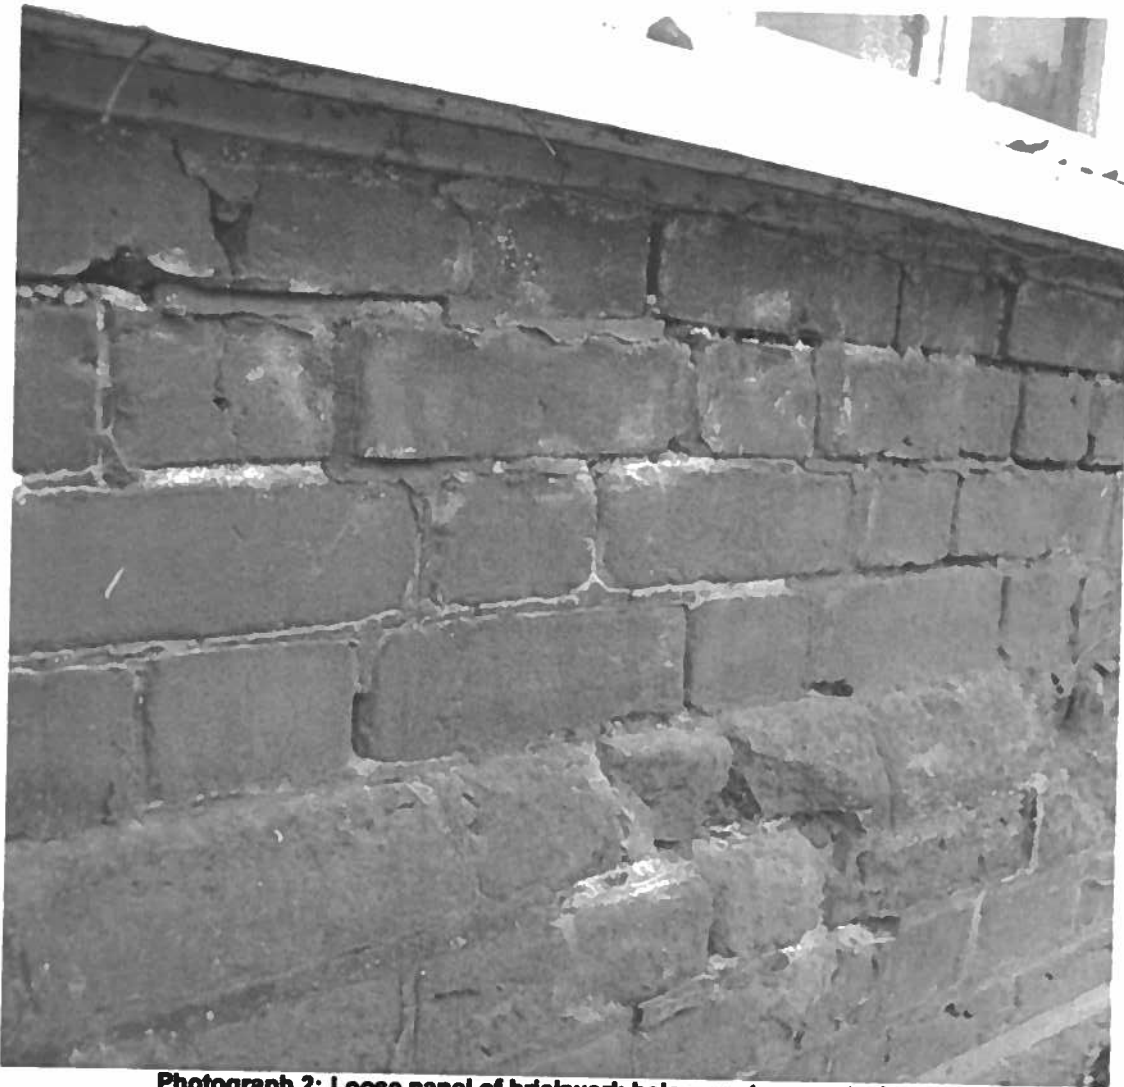
The panel between the head of this window and the first floor window is also slightly loose, and would benefit from pinning. This is a technique of drilling holes through individual bricks at a slight downward angle, and then inserting stainless steel threaded rod, or proprietary anchors such as Helibar, and setting them in resin. This is essentially providing a tie between the external leaf and the backing brickwork. The holes are then made good with a brick dust mortar to match. We attach some specification notes for this work.

Photograph 2: Loose panel of brickwork below easternmost window

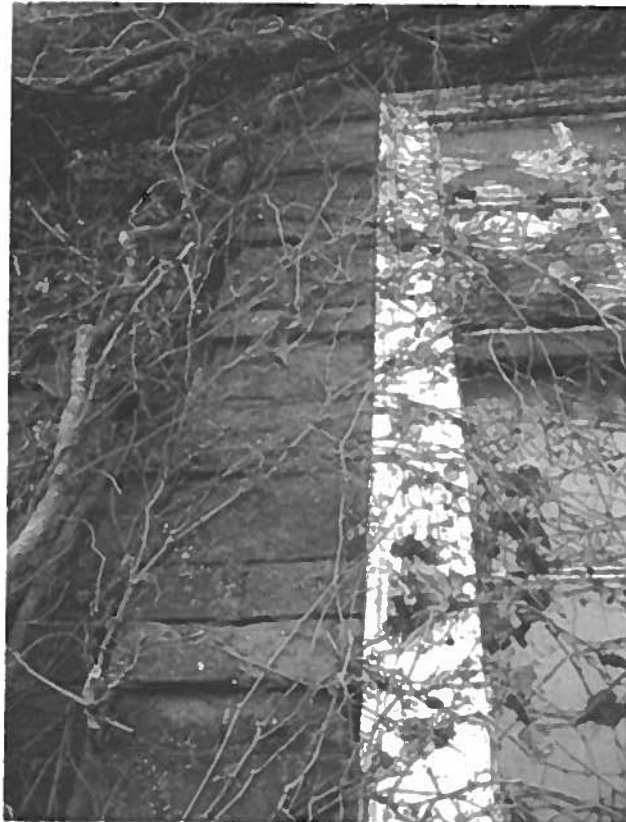
Photograph 4: Set forward brickwork adjacent to window reveal found to be loose

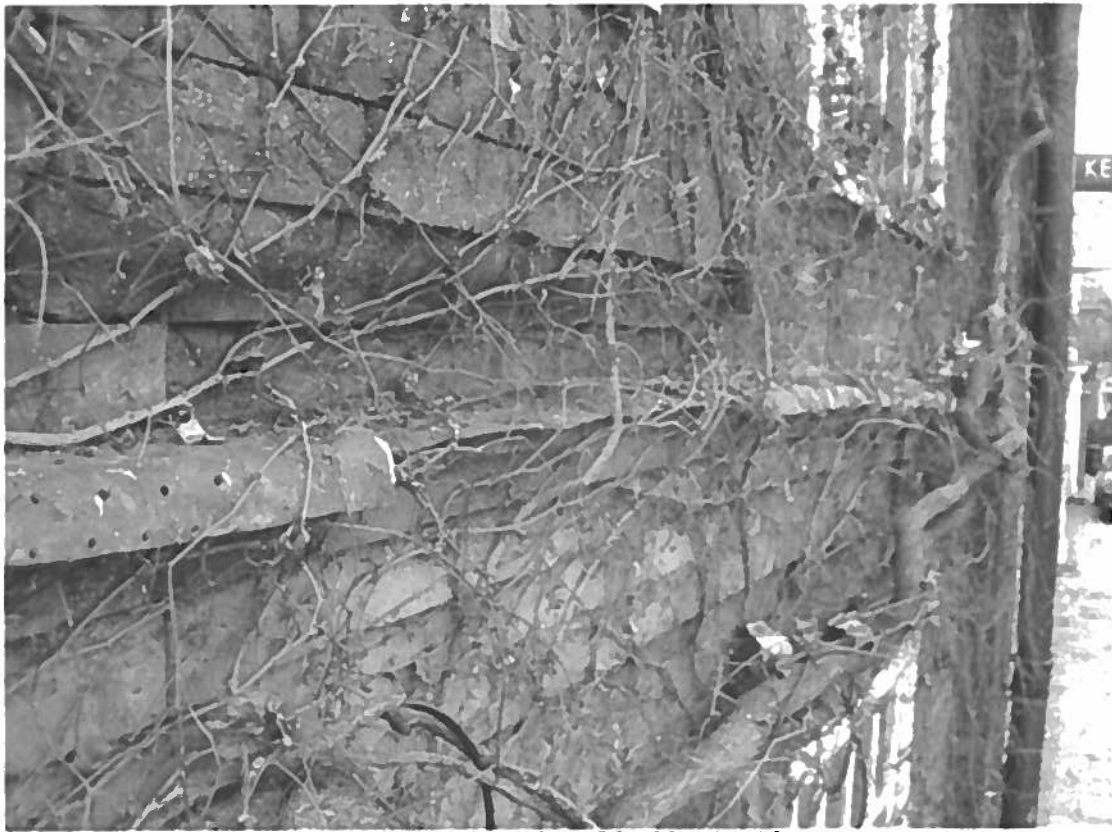
Photograph 5: Missing section of flashing to string course

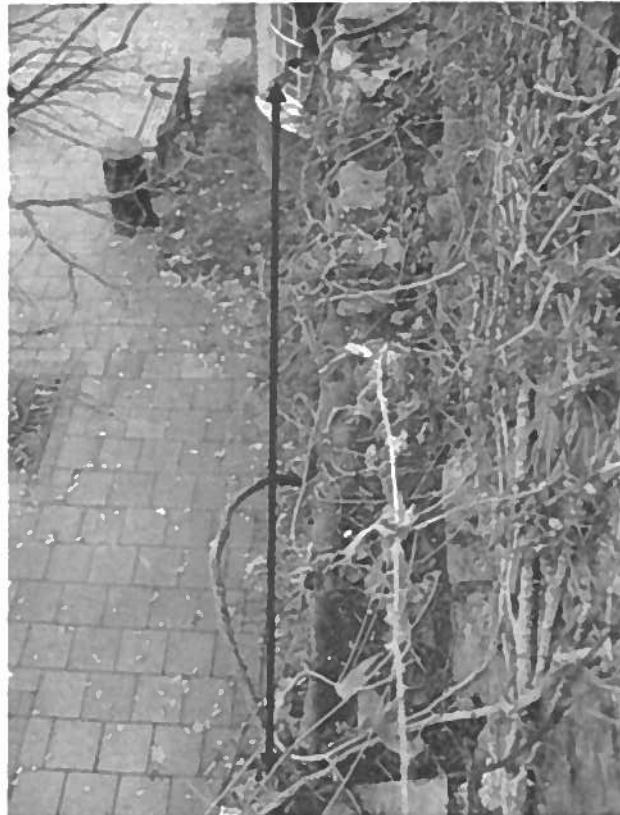
Photograph 6: Missing length of cornice flashing

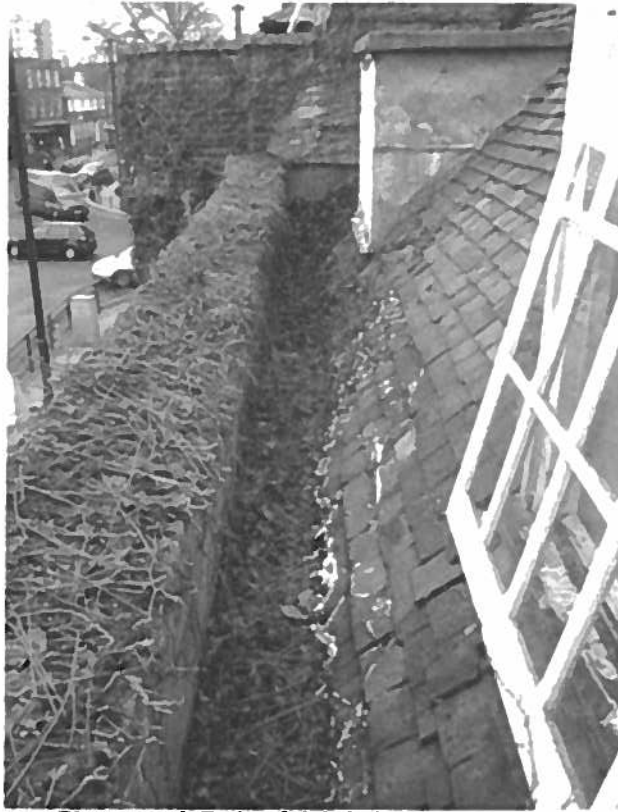
Photograph 7: Leaf debris in parapet gutter

Item	Old House	Estimated Cost (£)
1.0	Roof	
1.1	Clear all uPVC gutters and downpipes and ensure they are in full working order.	
1.2	Remove all plant growth, mosses, dead leaves, debris and any other loose or unused items from all valley, and parapet gutters and flat roofs. Virginia Creeper – cut back from parapet copings, bay window roof and window openings.

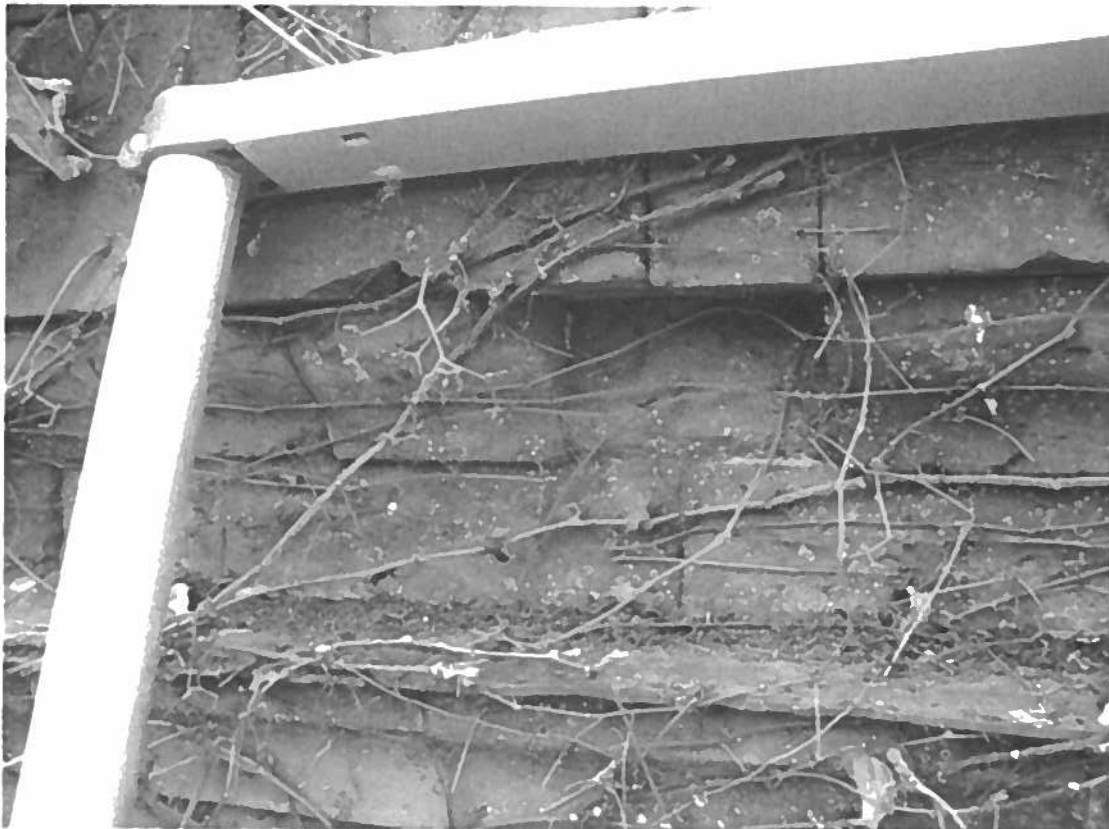
Photograph 8: Locally decayed bricks,

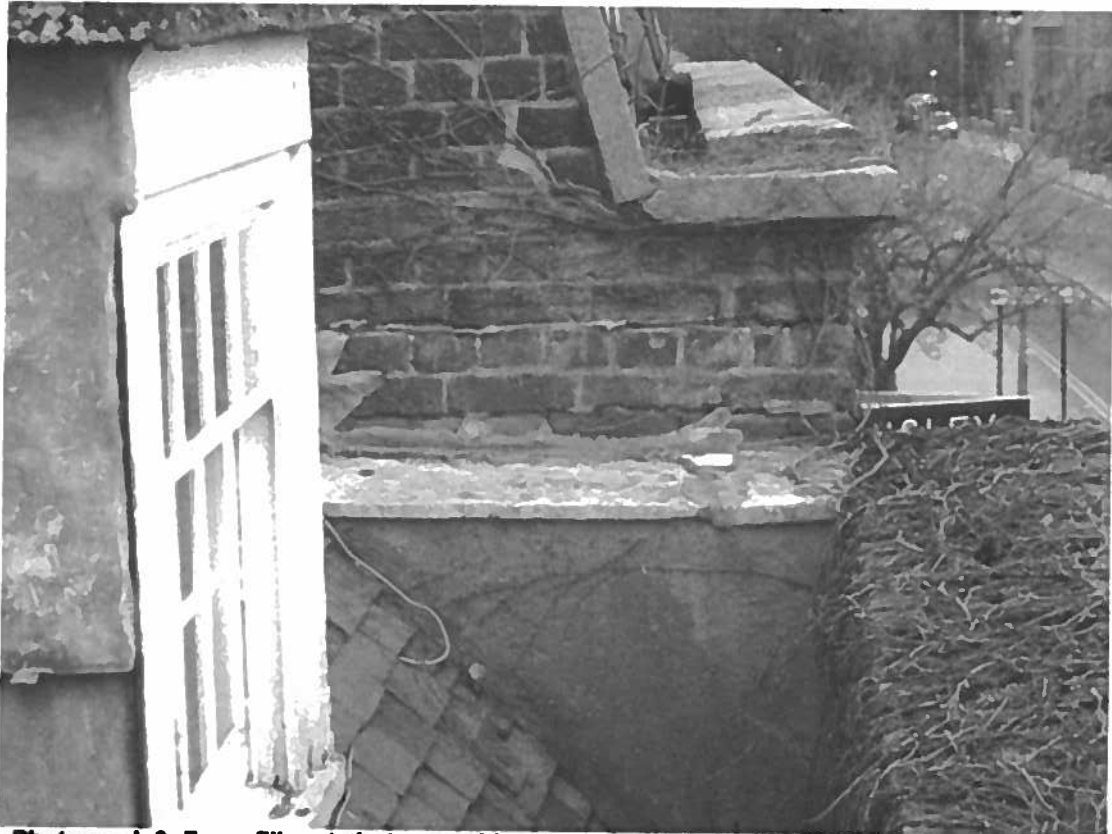
Photograph 9: Foam filler at abutment with adjoining building to east and missing flashing(?)

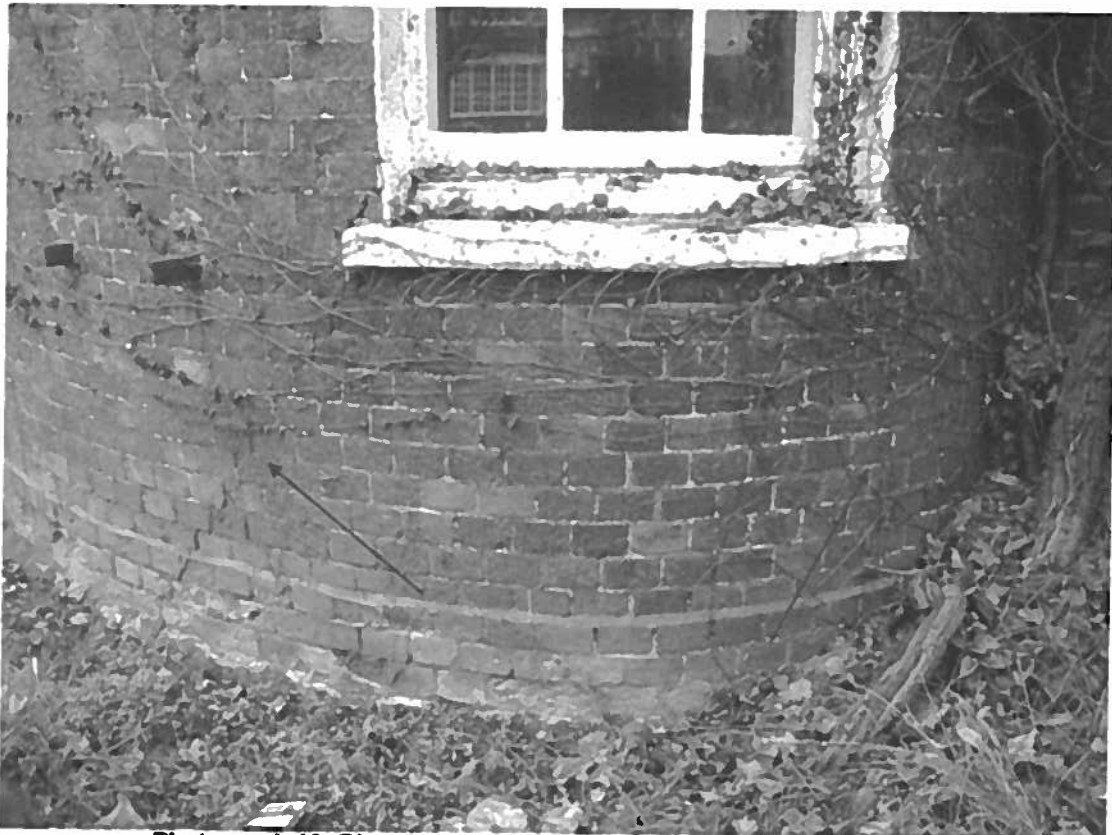
Photograph 10: Diagonal raking cracks below eastern window of bay

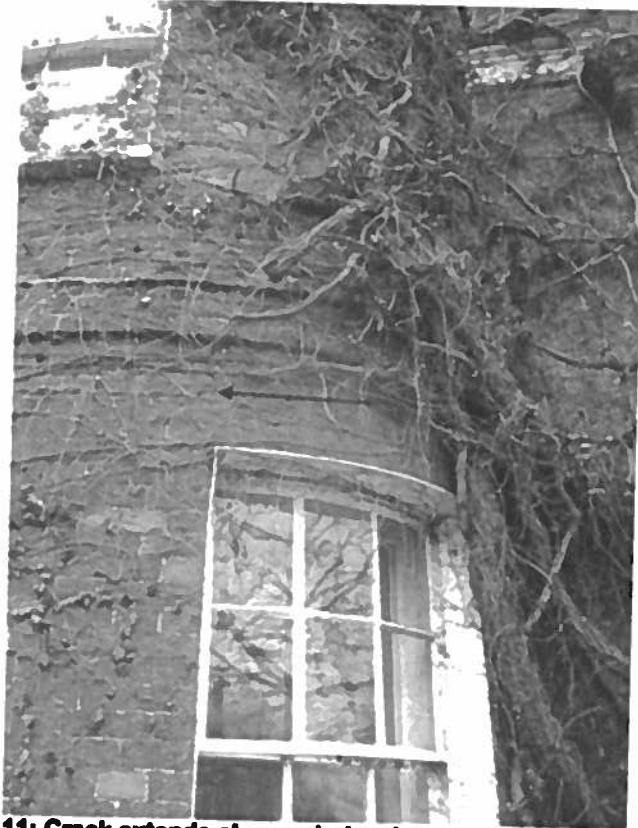
Photograph 11: Crack extends above window but partial concealed by creeper

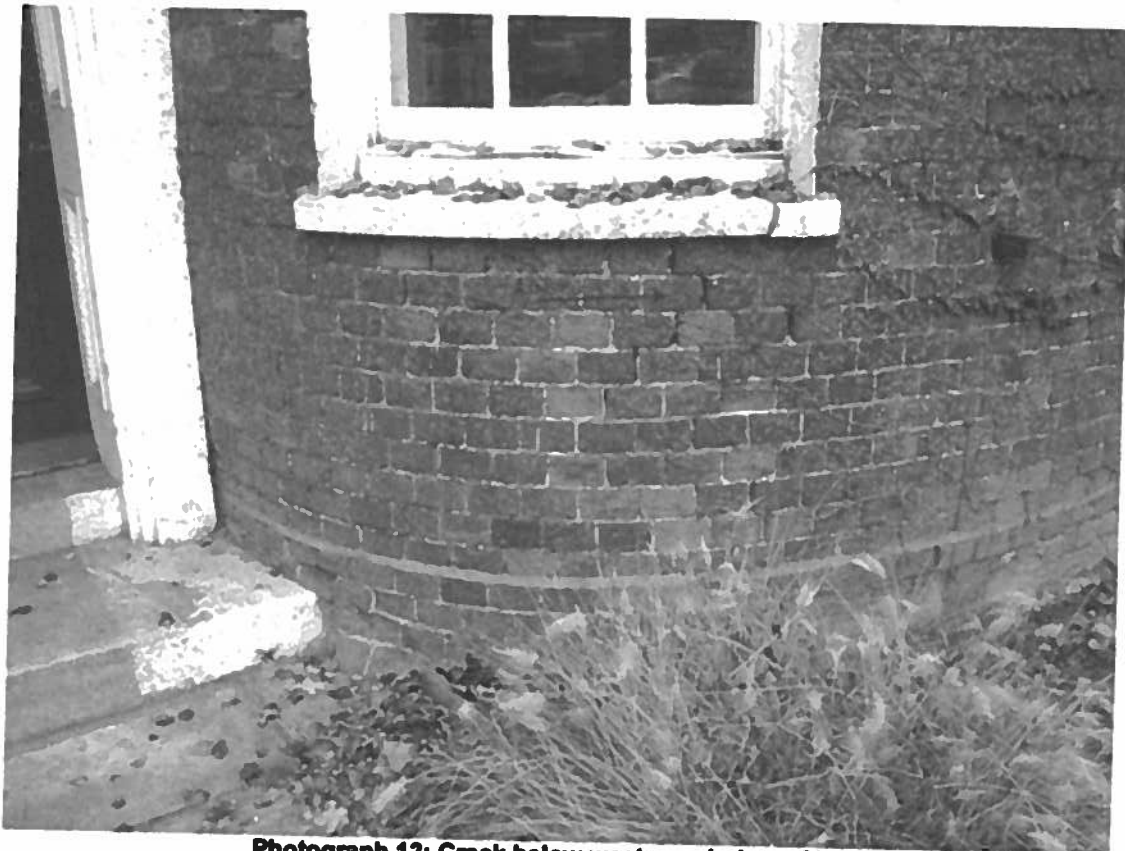
Photograph 12: Crack below western window of bay

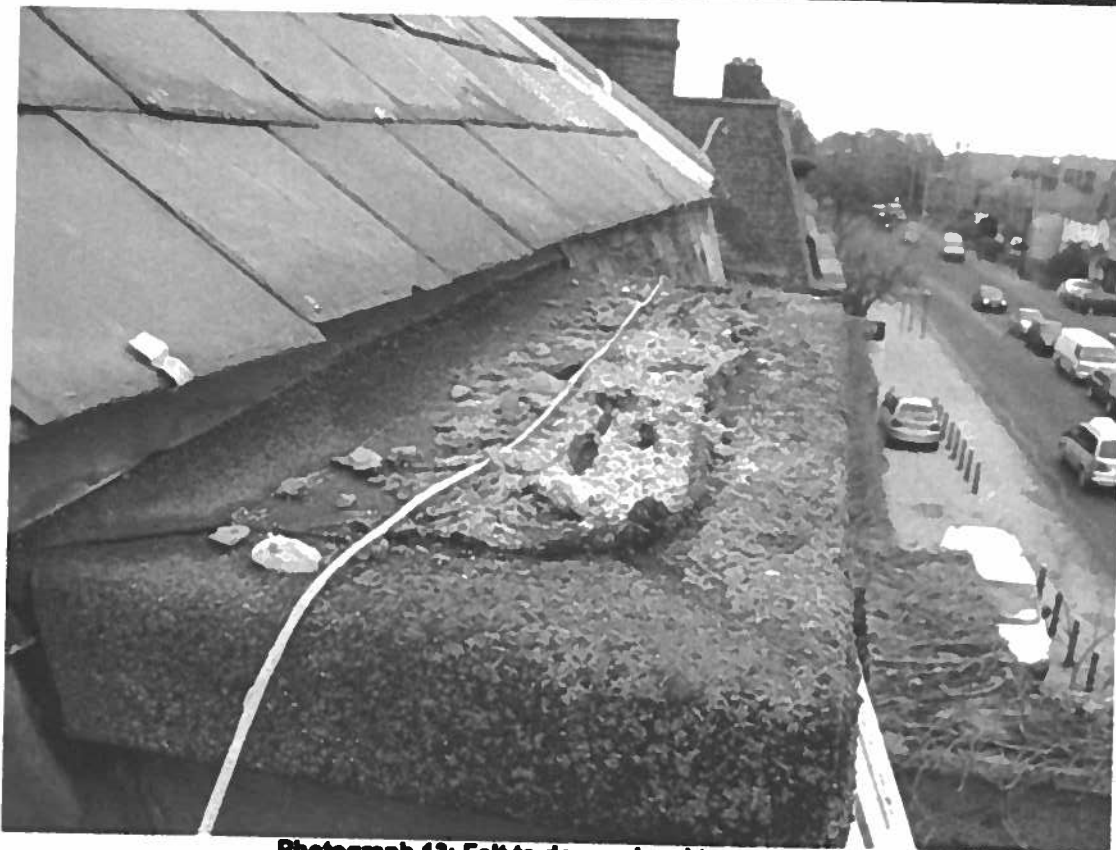
Photograph 13: Felt to dormer head to west end

1.3	Allow to inspect parapet gutters, flashings, lower tile courses, copings and bay window roof and repair as necessary in matching materials.	
1.4	Existing decayed felt to the roof of the front and rear mansard dormer windows with new felt – replace with new felt. Allow to inspect felt to the dormers (2 front, 1 rear) of lower tiled roof and repair/replace in felt as necessary.

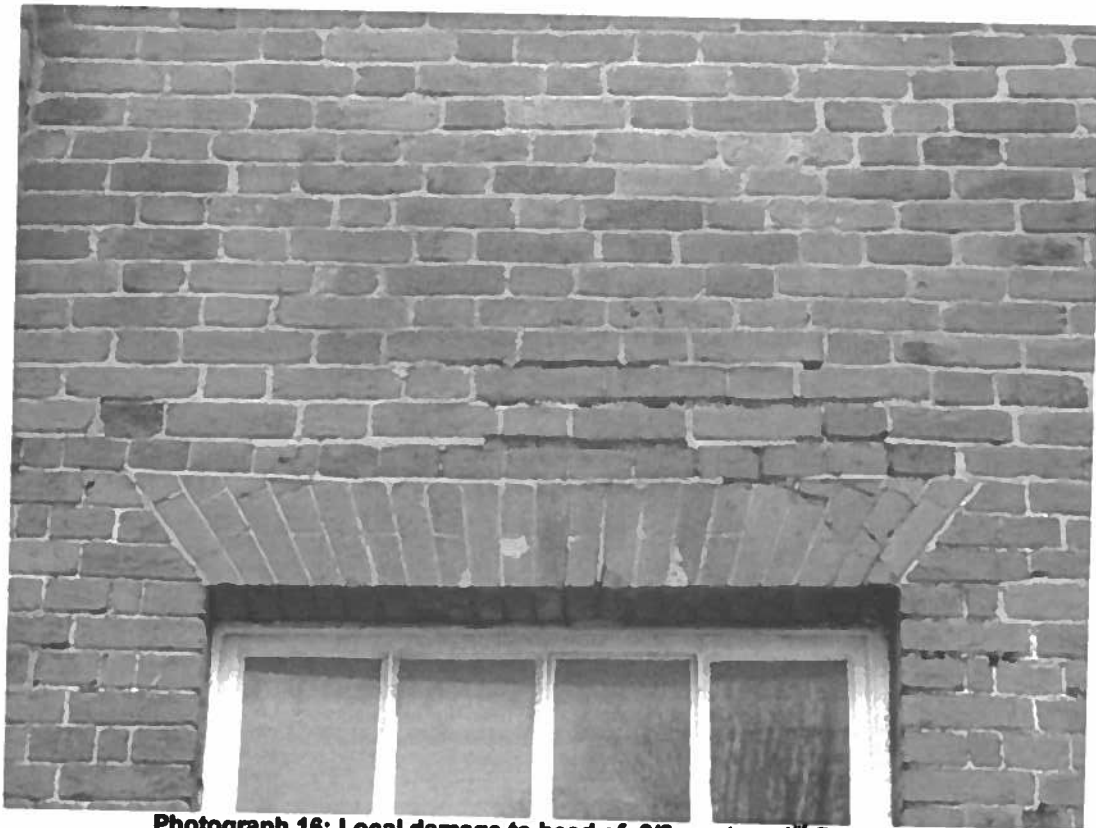
Photograph 16: Local damage to head of 8/8 western 1st floor sash

4.0	Joinery	
4.1	Joinery –fully repair/overhaul and leave in sound and fully operable condition. Works to include: repair of rotten timbers, replacing missing parts (e.g., sash cords), re-balancing and re-decorating. Repair/replace secondary glazing throughout.
