**Re: Hutton Community Centre, Brentwood CM13 1LP**

Further to my inspection on 1 August 2014, I outline below my findings and views in respect of the roofs at the above property:

We have been instructed by John Parling of Brentwood Council to inspect the roofs at Hutton Community Centre and provide commentary in respect of the general repair, condition and life expectancy of the roofs.

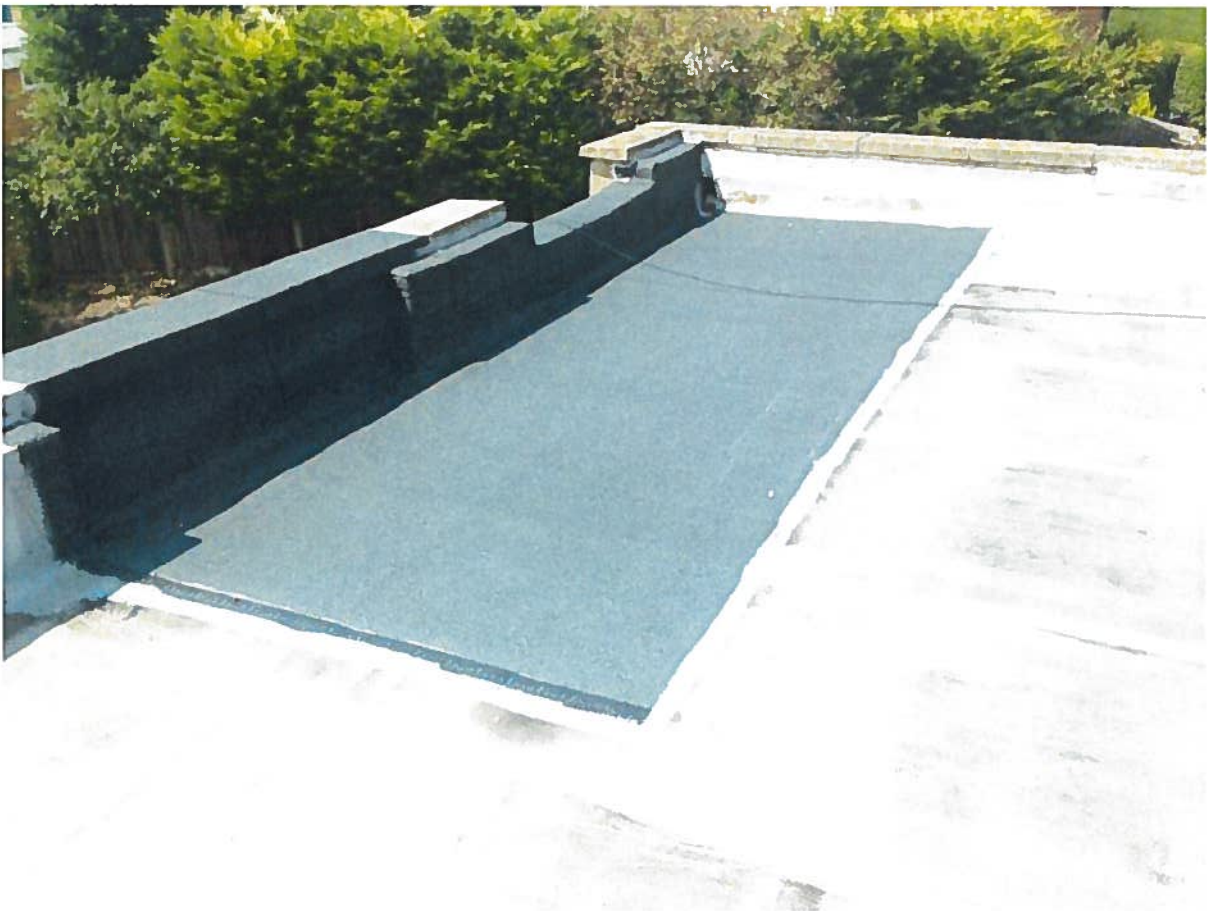
Roof 1 patch.jpg

Roof	Discussion	Lifecycle Replacement
Roof 1	This roof weathers the large hall and comprises felt weatherings with a solar reflective coating. It appears to be formed on a prefabricated woodwool slab deck. The coverings themselves are in fair condition with some minor deterioration apparent and with evidence of a few isolated patch repairs undertaken to presumably resolve historic leaks. The roof is found in overall fair condition.	It is our opinion that this roof has a useful life of between 5-10 years before replacement will be necessary.
Roof 2	This roof has a felt covering with stone chippings, with sections of it overlaid with mineral felt. This roof covers the main entrance and central reception area primarily and is assumed to have a timber deck construction. This is an example where the general detailing to the adjoining roofs and previous repairs are questionable in terms of their longevity and ability to remain watertight. Patch repairs have been undertaken to address a recently reported leak, but we cannot be certain that these repairs have been successful and we very much doubt that they will come with any form of guarantee. The falls are deemed to be fair and the box gutter detail formed appears to be performing as required.	We anticipate reasonable expenditure will be necessary by way of an overlay or replacement to this roof area within the next five years on the basis the roof is at the end of its useful life.

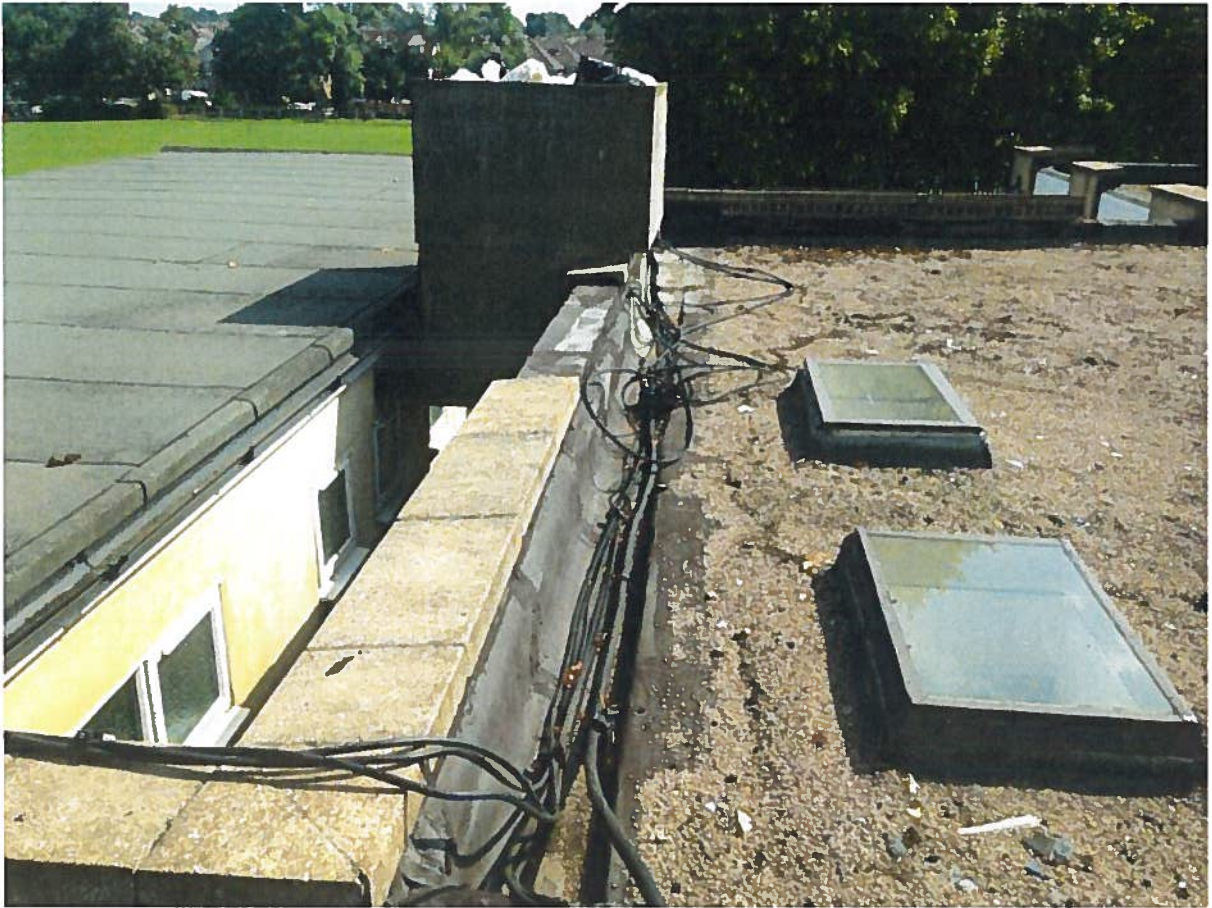
Roof 3.jpg

Roof 3	This roof is similar to Roof 2 and weathers the café / lounge area at the rear of the building. Patch repairs are apparent to the weatherings, plus Acrypol type repairs to the roof lights and extract vent, which are in effect short term repair solutions. Detailing to the flashings and upstands are poor in areas, however the roof does appear to fall and drain adequately via an internal downpipe.	This roof is also at the end of its useful life and we would recommend an overlay or replacement to be considered within the short term, and ideally at the same term as works to Roof 2.
Roof 4	This roof appears to have been overlaid with a felt system and is seen in overall fair condition albeit detailing to the roof light is poor, and with evidence of some patch repairs also to a poor standard.	The main covering should have a life cycle of between 5-10 years; however some of the previous repairs and detailing will require attention in the short term and there is a benefit of including the overlay or replacement of this roof whilst doing the same to the immediately surrounding roofs.

On the basis these roofs have not been subject to good maintenance and they have broadly reached the end of their useful life it is our opinion that there will be further failings by way of leaks. We therefore recommend that roofs 2, 3, 4, 5 & 6 should be overlaid (in a single phase of works) with insulation and a mineral felt system to provide a 20 year insurance backed guarantee and that these works are carried out as soon as possible. In doing so, we would strongly advise that upstands, parapets, rooflights and drainage is reviewed, improved and encapsulated to benefit from the guarantee. This will address a large amount of the overall roof area and provide a basis for a planned replacement of the remaining roofs over a 10 year period (as well as helping improve the buildings EPC rating).

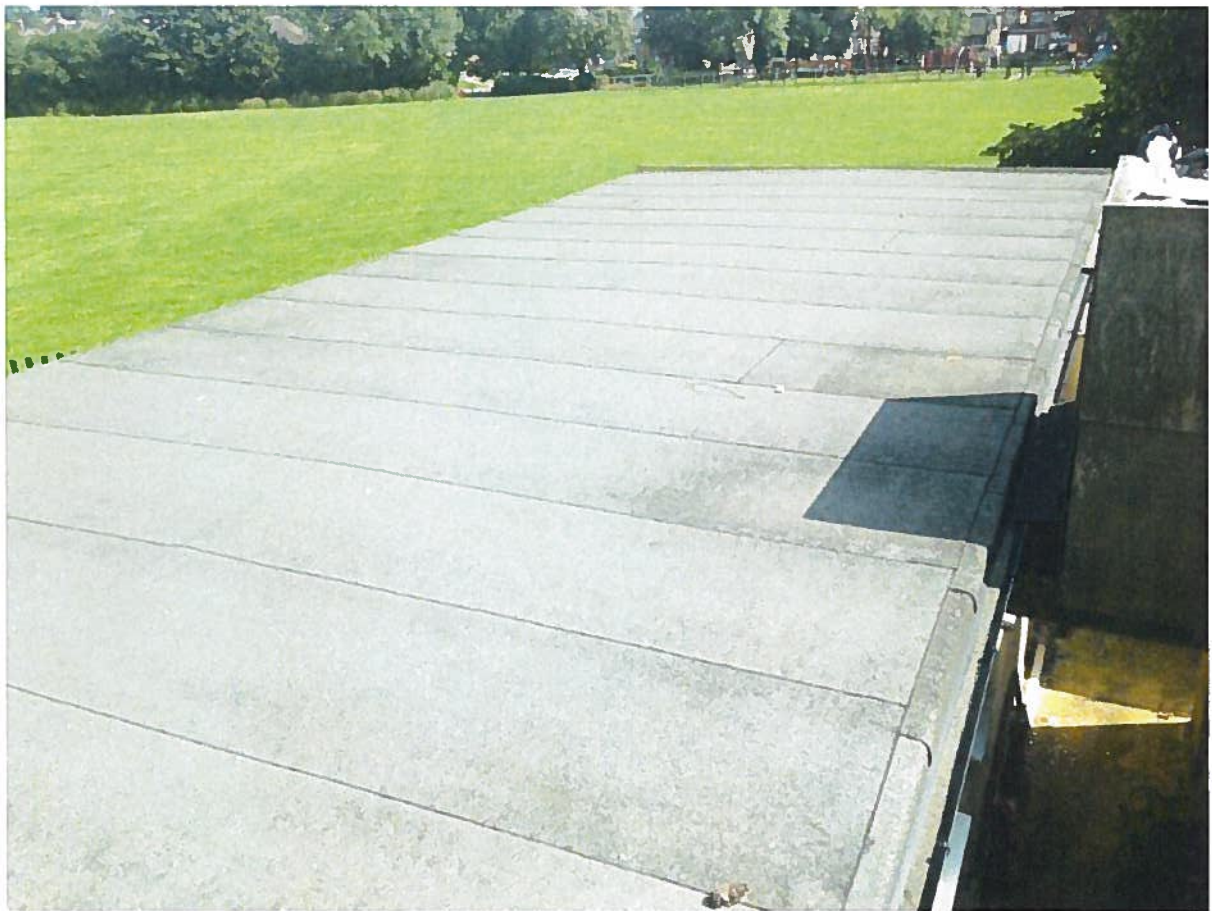
Roof 8.jpg

Roof 7	This is a felt weathered flat roof which is found in overall fair condition with some minor maintenance required, but otherwise no significant defects noted.	We would estimate this roof has a useful life of up to ten years.
Roof 8	This roof covers the football changing rooms and is the same as Roof 7, with the only minor defect noted to be the standing water within the rainwater goods, which can be overcome by way of minor adjustments.	Again we are of the opinion that this roof has a useful life of in the order of ten years.

The other roofs should then be subject to a planned maintenance programme with replacement anticipated in the mid to longer term. A planned maintenance programme would be beneficial to help manage and prolong these roofs.

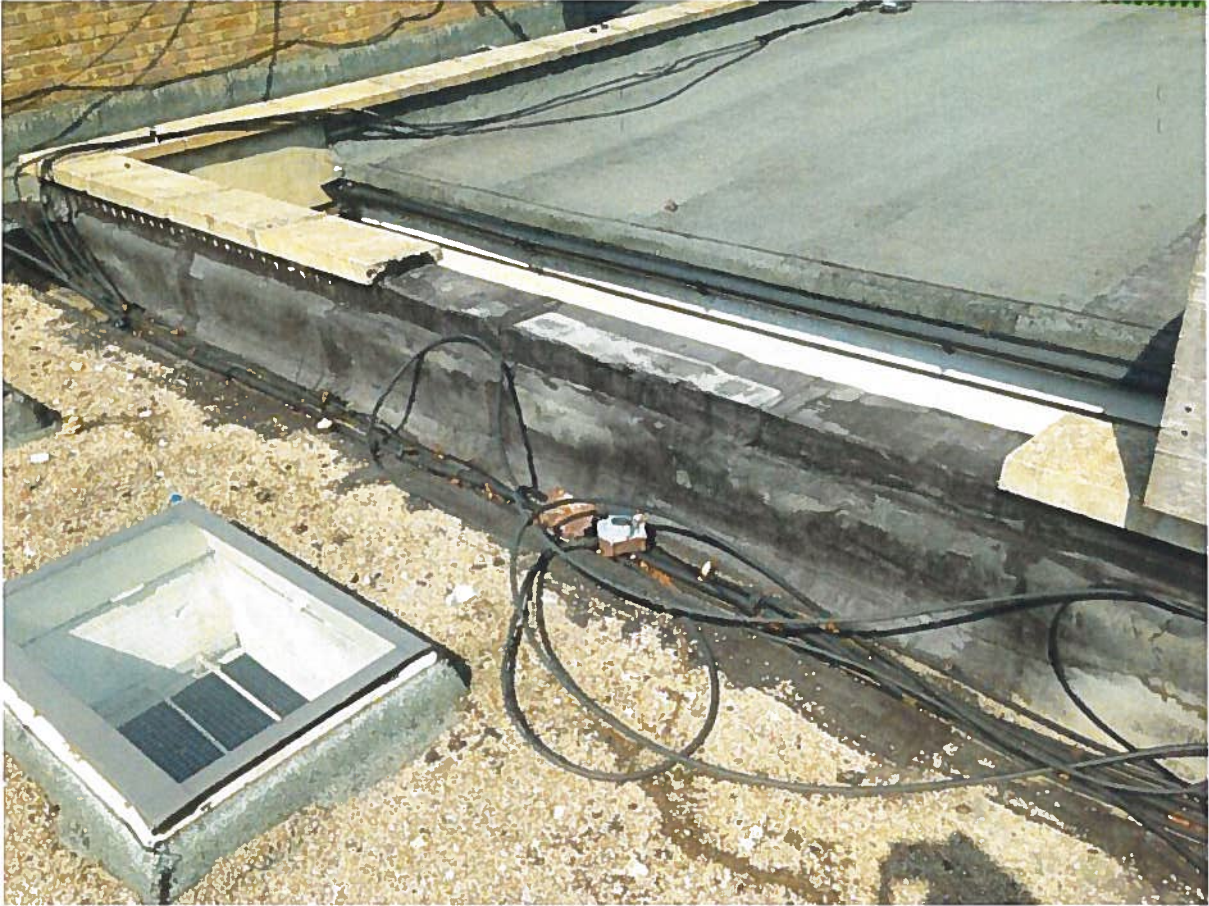
Roof 9.jpg

Roof 9	This roof has felt weatherings which are found in overall fair condition, and with some patch repairs apparent that appear well detailed. GRP roof lights are solar degraded; otherwise no significant defects or shortcomings are noted.	We would expect this roof to have a useful life of up to ten years. However, replacing the roof lights or alternatively removing them and capping over in the short term would be beneficial.
Roof 10	This roof has felt weathering and covers the Small hall to the front left hand corner of the building. It appears in fair condition overall, however the perimeter upstands and parapets are untidy and present an opportunity for future failings.	We are of the opinion this roof will need to be overlaid in approximately five years when it will be at the end of its useful life.

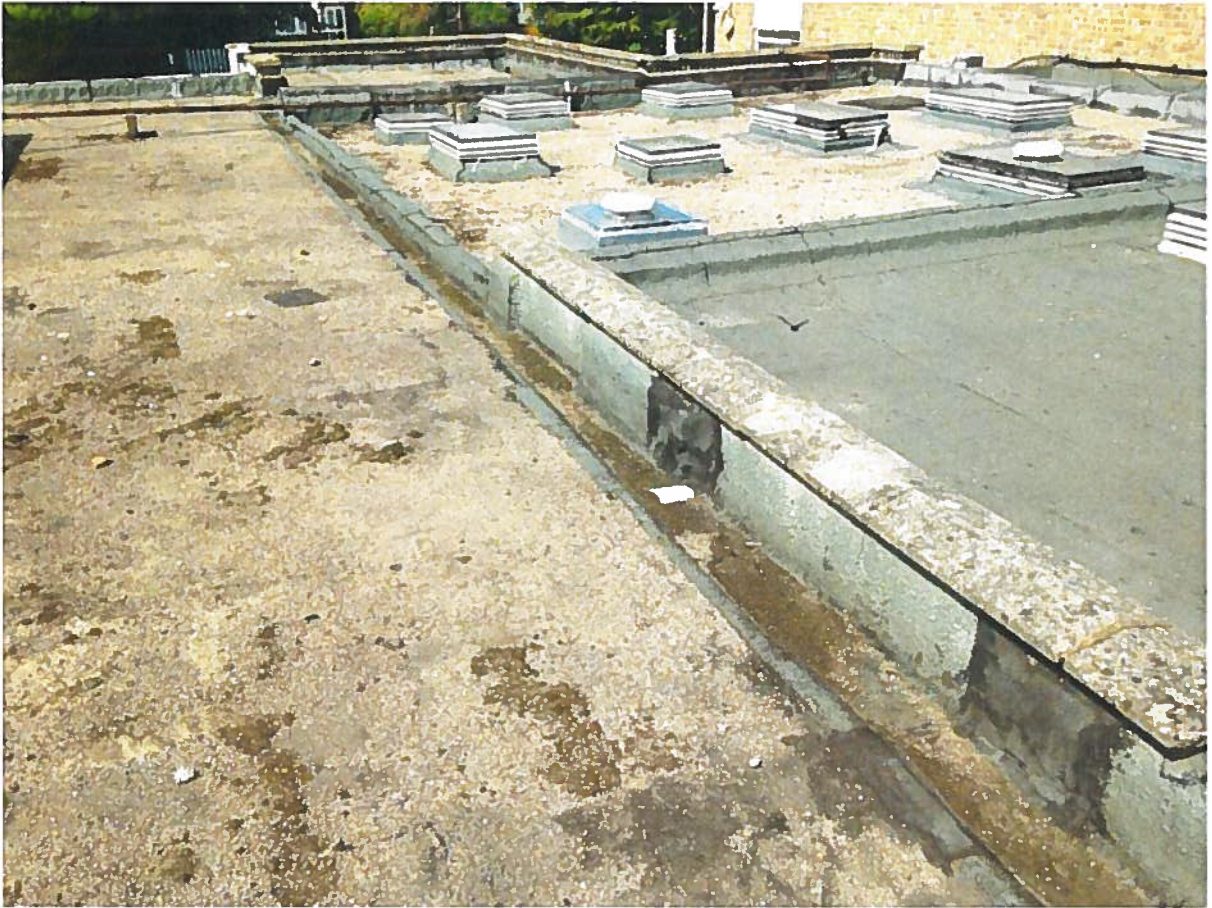
View from roof 5.jpg

Roof 5	This roof has a combination of felt with chippings and mineral felt overlay, and again with the detailing at upstands and abutments found to be poor. Roof lights are dressed with flashband which is a short term repair solution. Standing water is noted adjacent to Roof 4 and we suspect the drainage from this roof is limited.	We are of the opinion that the roof is towards the end of its useful life and should be subject to an overlay or perhaps replacement in the short term and certainly within the next five years.
Roof 6	The main roof area is felt with stone chippings but with mineral felt dressings formed to the perimeter and abutment of the roof area, which would appear to have been undertaken to resolve previous defects. Blisters and splits in the weatherings are noted and defects to the parapet and flashings developing. Flashband treatment to the roof lights is again noted. The roof lights themselves include Georgian wire and GRP units, with the GRPs solar degraded.	We are of the opinion that the roof is at the end of its useful life and that an overlay or replacement should be considered, together with repairs and replacement to parapets and roof lights. It would be beneficial to do such works at the same time as the others, as described above.
