Asset and Enterprise Committee

Old House

The Old House, Brentwood

Conservation Statement

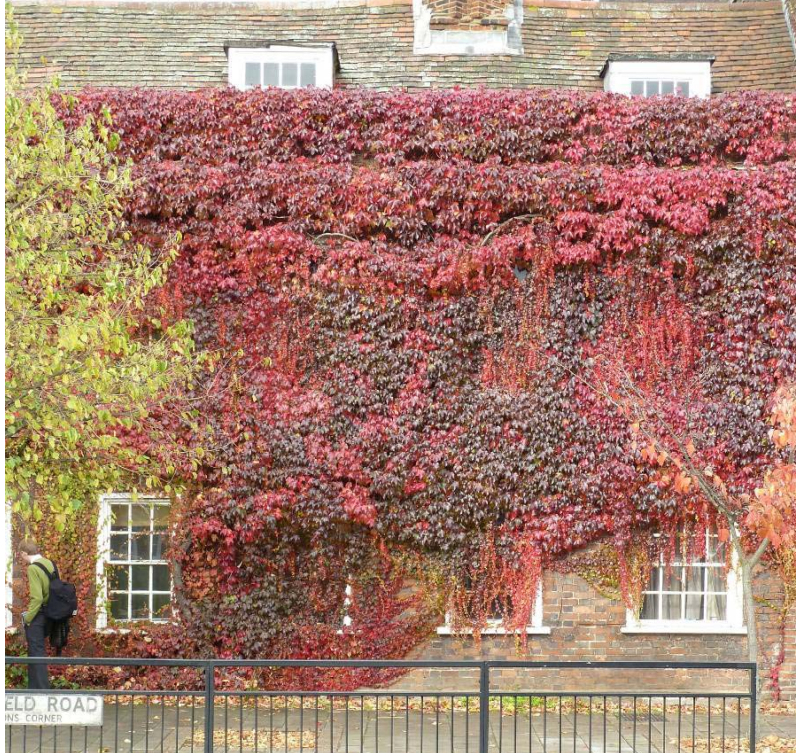
Much of this façade is now concealed by creeper making inspection and recording difficult. There is evidence of penny struck pointing to the brickwork.

Shenfield road façade (east)

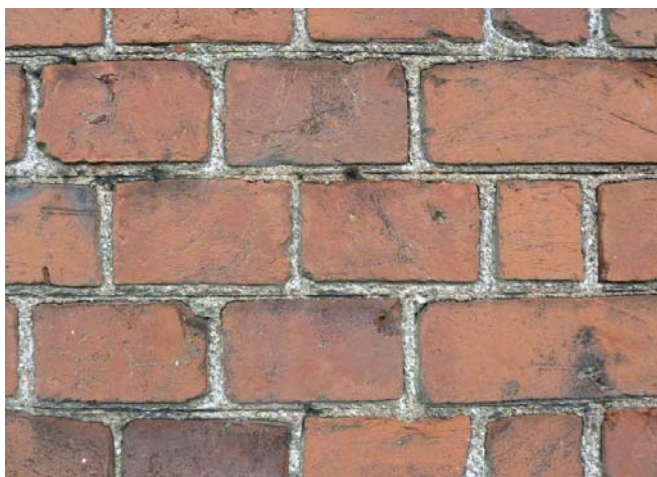
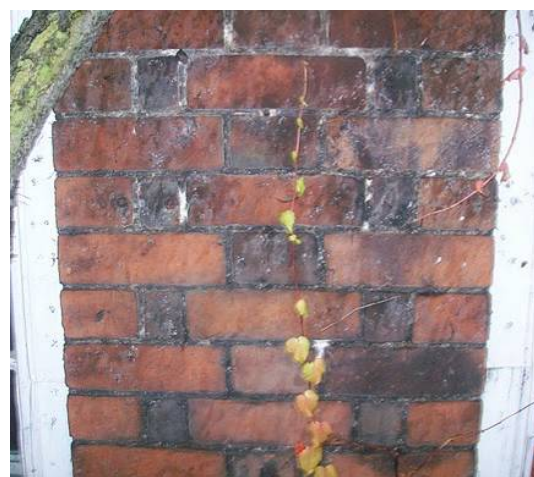
Penny struck pointing, flared headers and queen closers to both front and rear elevations

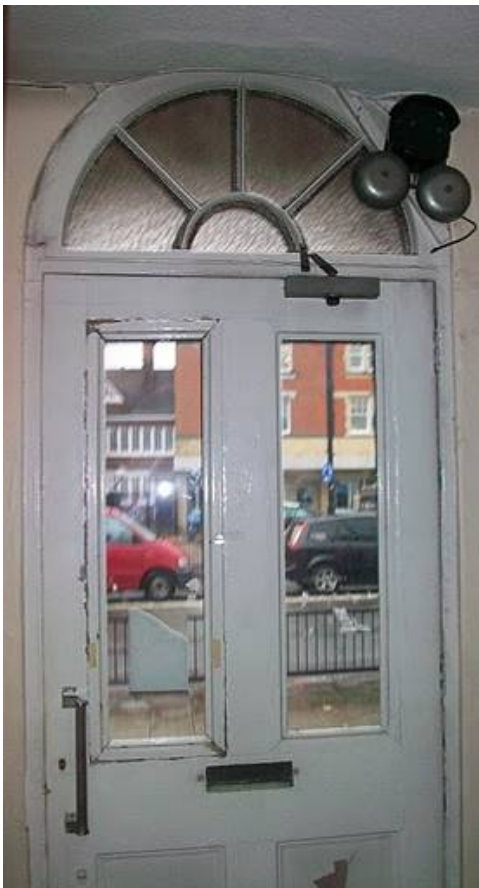
The old four panelled front door has been repaired at the bottom and has a semi circular fanlight above. The lobby has a moulded skirting board and there is a modern glazed screen between the entrance lobby and Room no. 6.

Left: Four panelled front door with fanlight

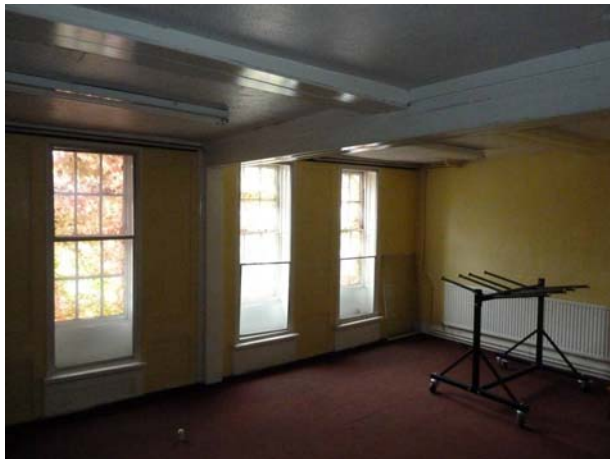
The room contains four of the façades six sash windows, all of which have shutters which are not in operation due to painted hinges and secondary glazing. The creeper on the front of the building has penetrated through the windows. The first two sashes from the west have a more elaborate moulding than those to the east which have only a recessed panel with no moulding. The third window from the west is a modern replacement and has horns on both the upper and lower sash. All of the windows have low sills with panelling beneath.

Left: Room 4 – Three (of four) sashes – Binding joist probably supported by RSJ

Works to the original windows should be limited to their repair and maintenance. Given the scale of internal alterations, the sash windows and their shutters are a remarkable survival. Although some secondary glazing is present, it has not been applied to all of the windows and where it has been some units are damaged or missing. When contemplating work to the windows, the possibility should be considered of returning the window shutters to operation. They would add character to the building whilst providing

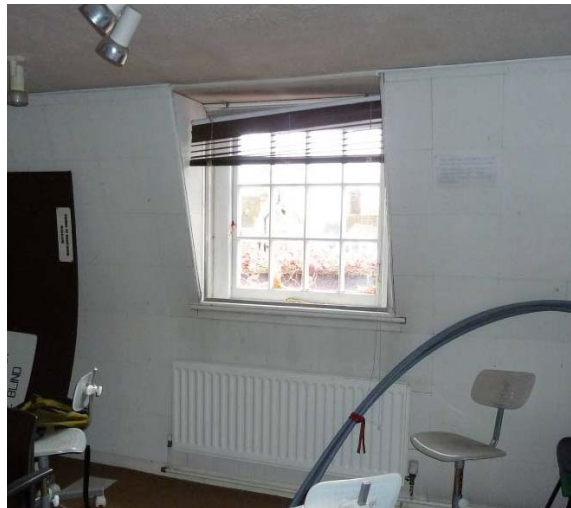
The ceiling has suffered damage where the valley gutter has leaked subsequent to the theft of lead from the roof.

Talking newspaper (East) – lined with acoustic tile

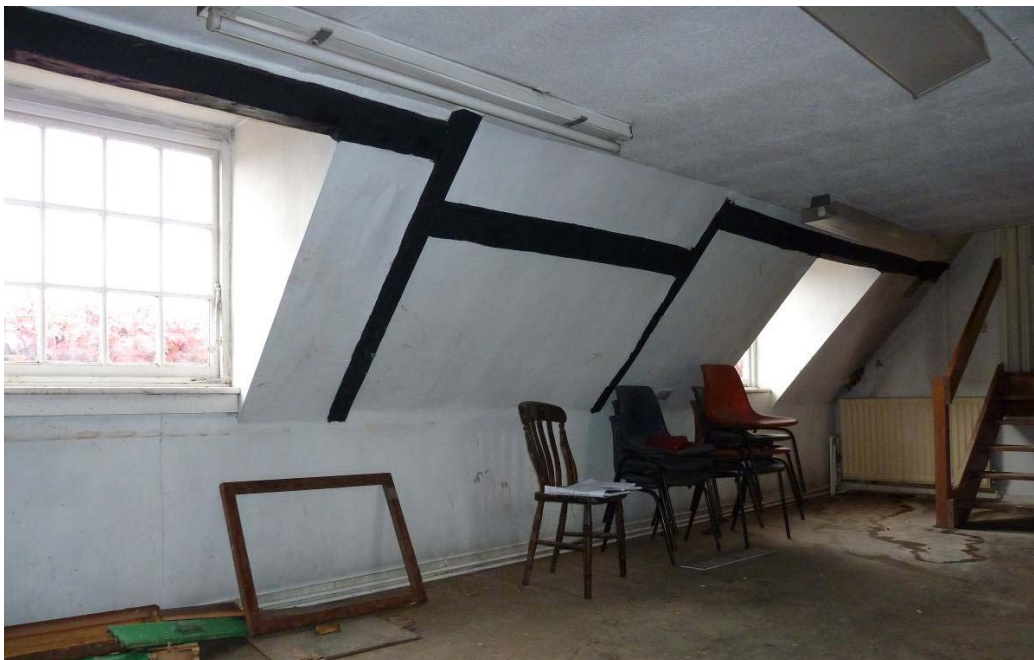
Through the dormer windows it is possible to see that the creeper is blocking the parapet gutters.

Joggled butt side purlin roof structure

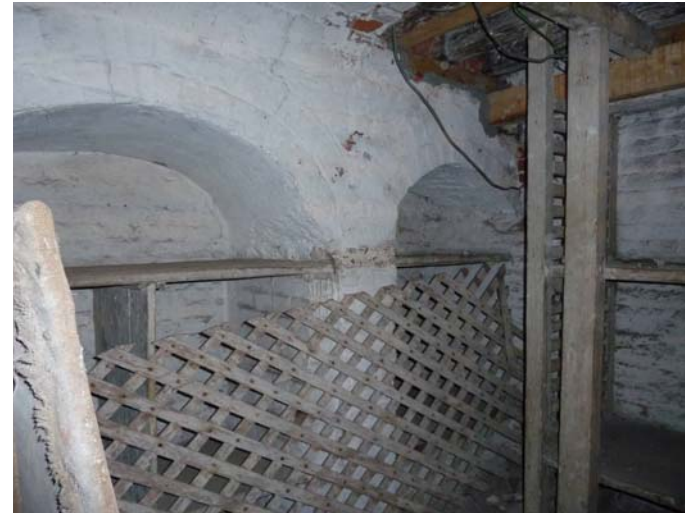
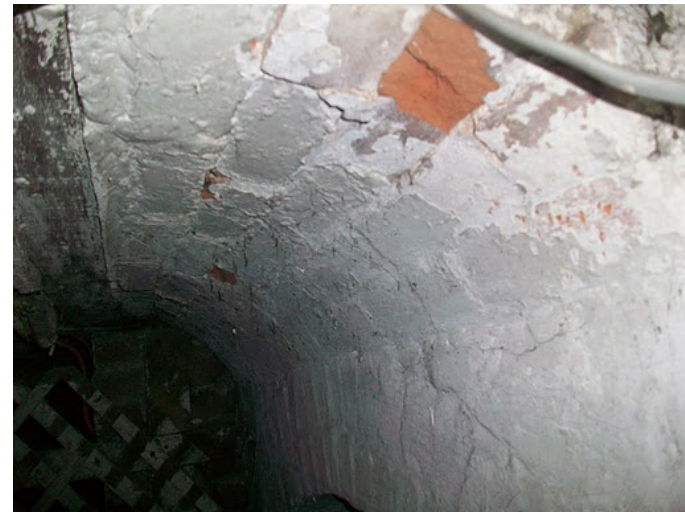
Left: Ventilated storage area - bridging and joists visible with repairs

Top right: Arched brick alcoves in cellar

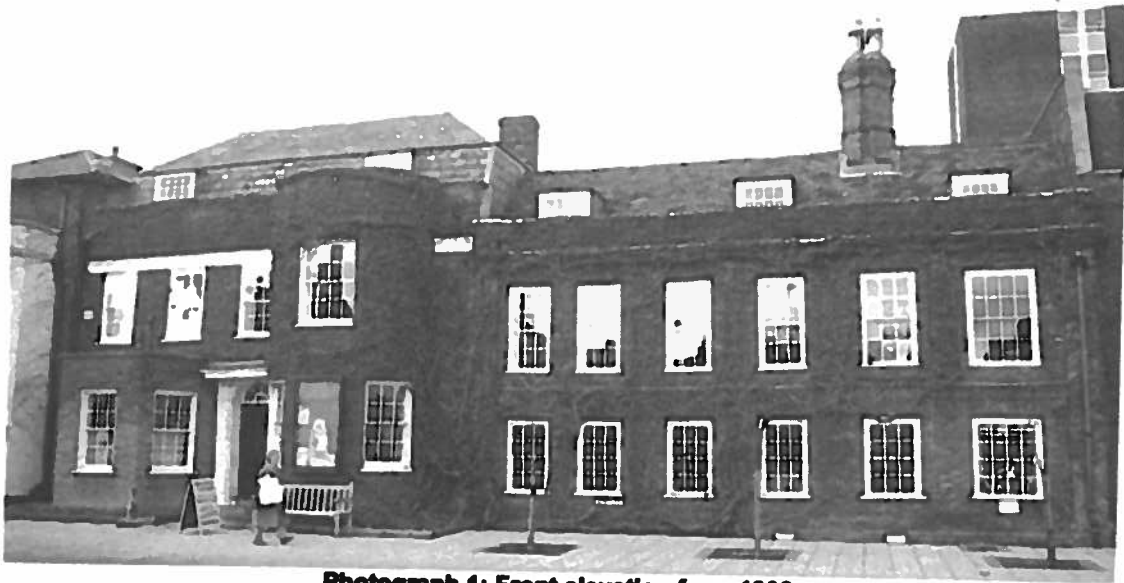
Photograph 1: Front elevation from 1990

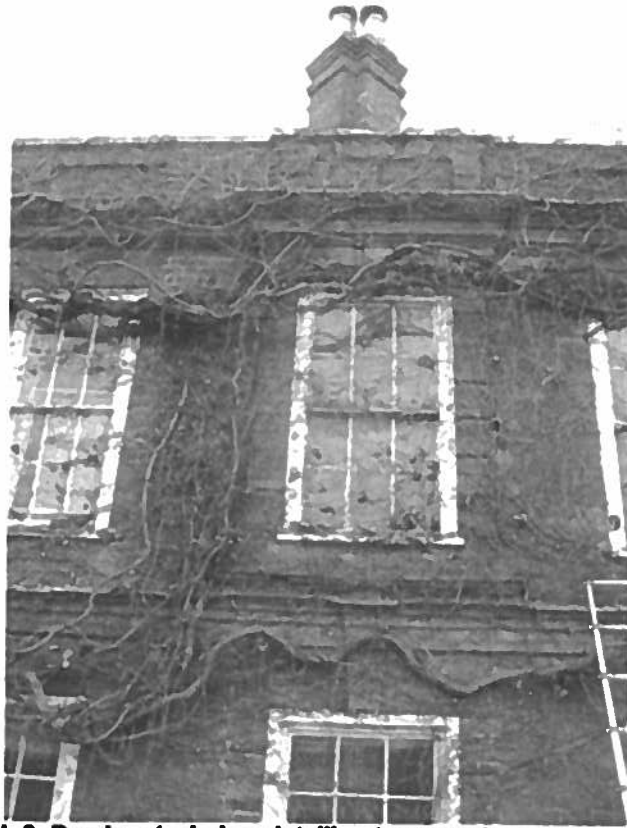
Photograph 3: Dominant window detailing to second window from east end

The second window from the east end, at first floor level, has been made more dominant by the brickwork being enhanced both to the sides, below and above this (see photograph 3). Generally, it projects by 20-25mm from the facework behind. This, through setting out, may weaken the bond with that behind, and certainly the set forward brickwork to either side of the window was quite loose when tapped (see photograph 4), and requires pinning back. The head and base of the window will need to be checked when scaffold access is available and the creeper removed to allow an improved check.

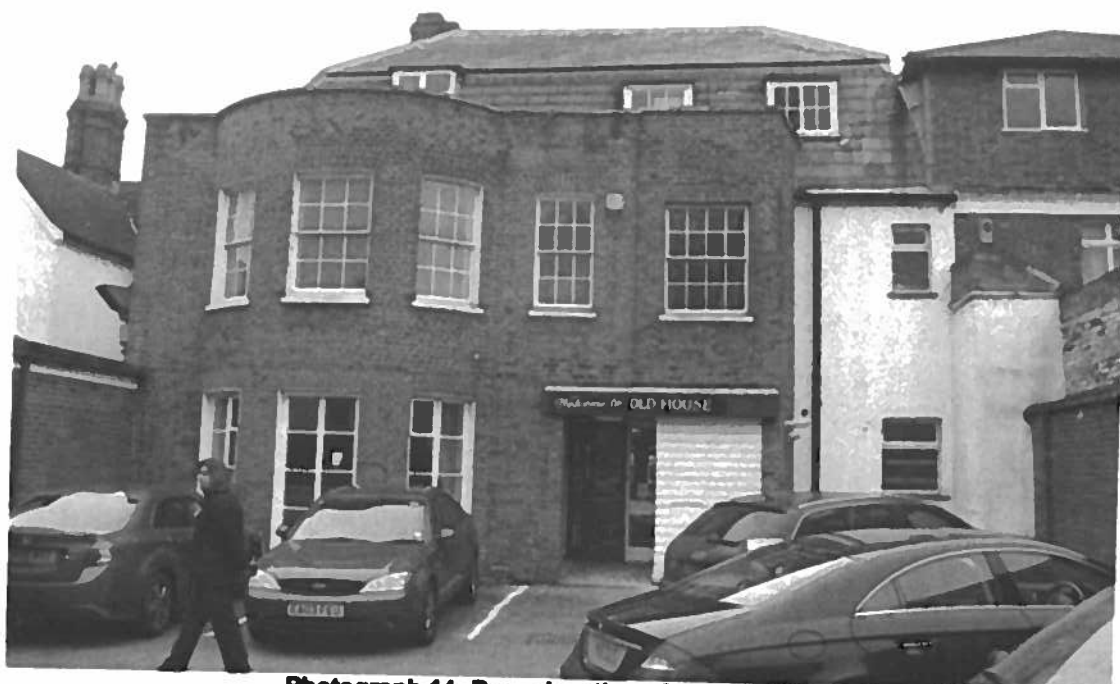
Photograph 14: Rear elevation of west building

To the rear elevation (see photograph 14 and 15) the condition of the brickwork generally appears reasonably except there is some local damaged to one window head to the west end at 1st level to the west building (see photograph 16). The damage looks old but certainly the panel of brickwork above need re-pointing and the arch should be checked at this time for stability. Some local pinning may be required at the west end where the bricks are fractured or alternatively the introduction of a flat bar lintel below.

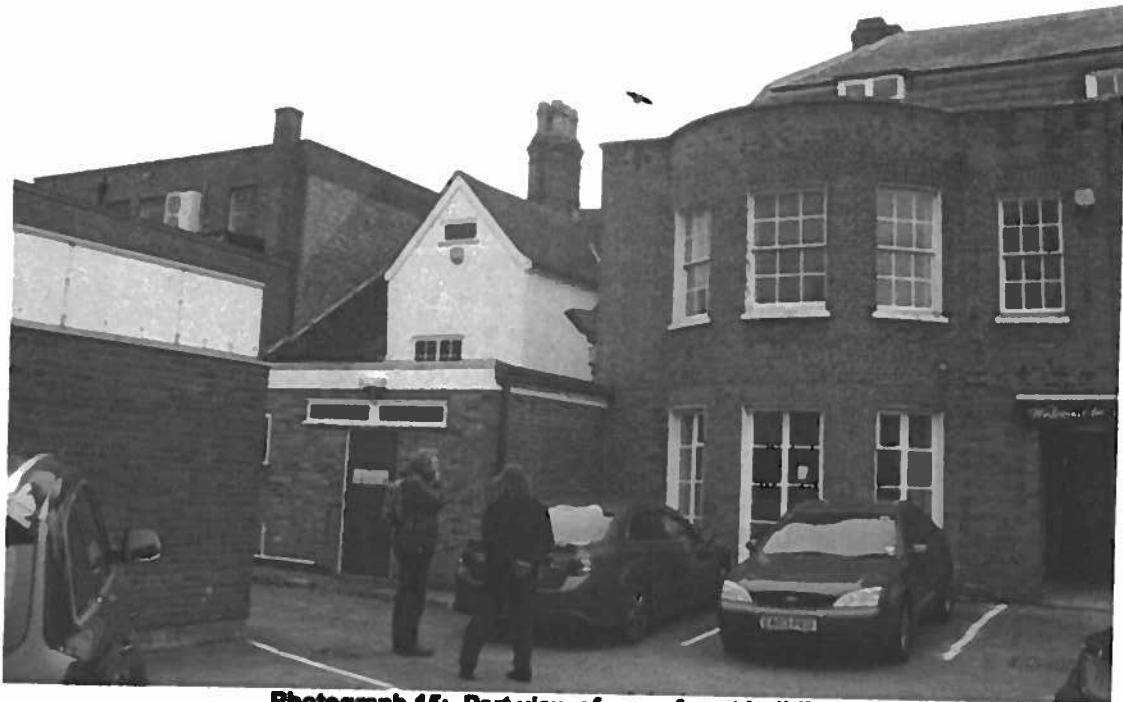
Photograph 15: Part view of rear of east building
