**Re: Hutton Community Centre, Brentwood CM13 1LP**

Further to my inspection on 1 August 2014, I outline below my findings and views in respect of the roofs at the above property:

We have been instructed by John Parling of Brentwood Council to inspect the roofs at Hutton Community Centre and provide commentary in respect of the general repair, condition and life expectancy of the roofs.

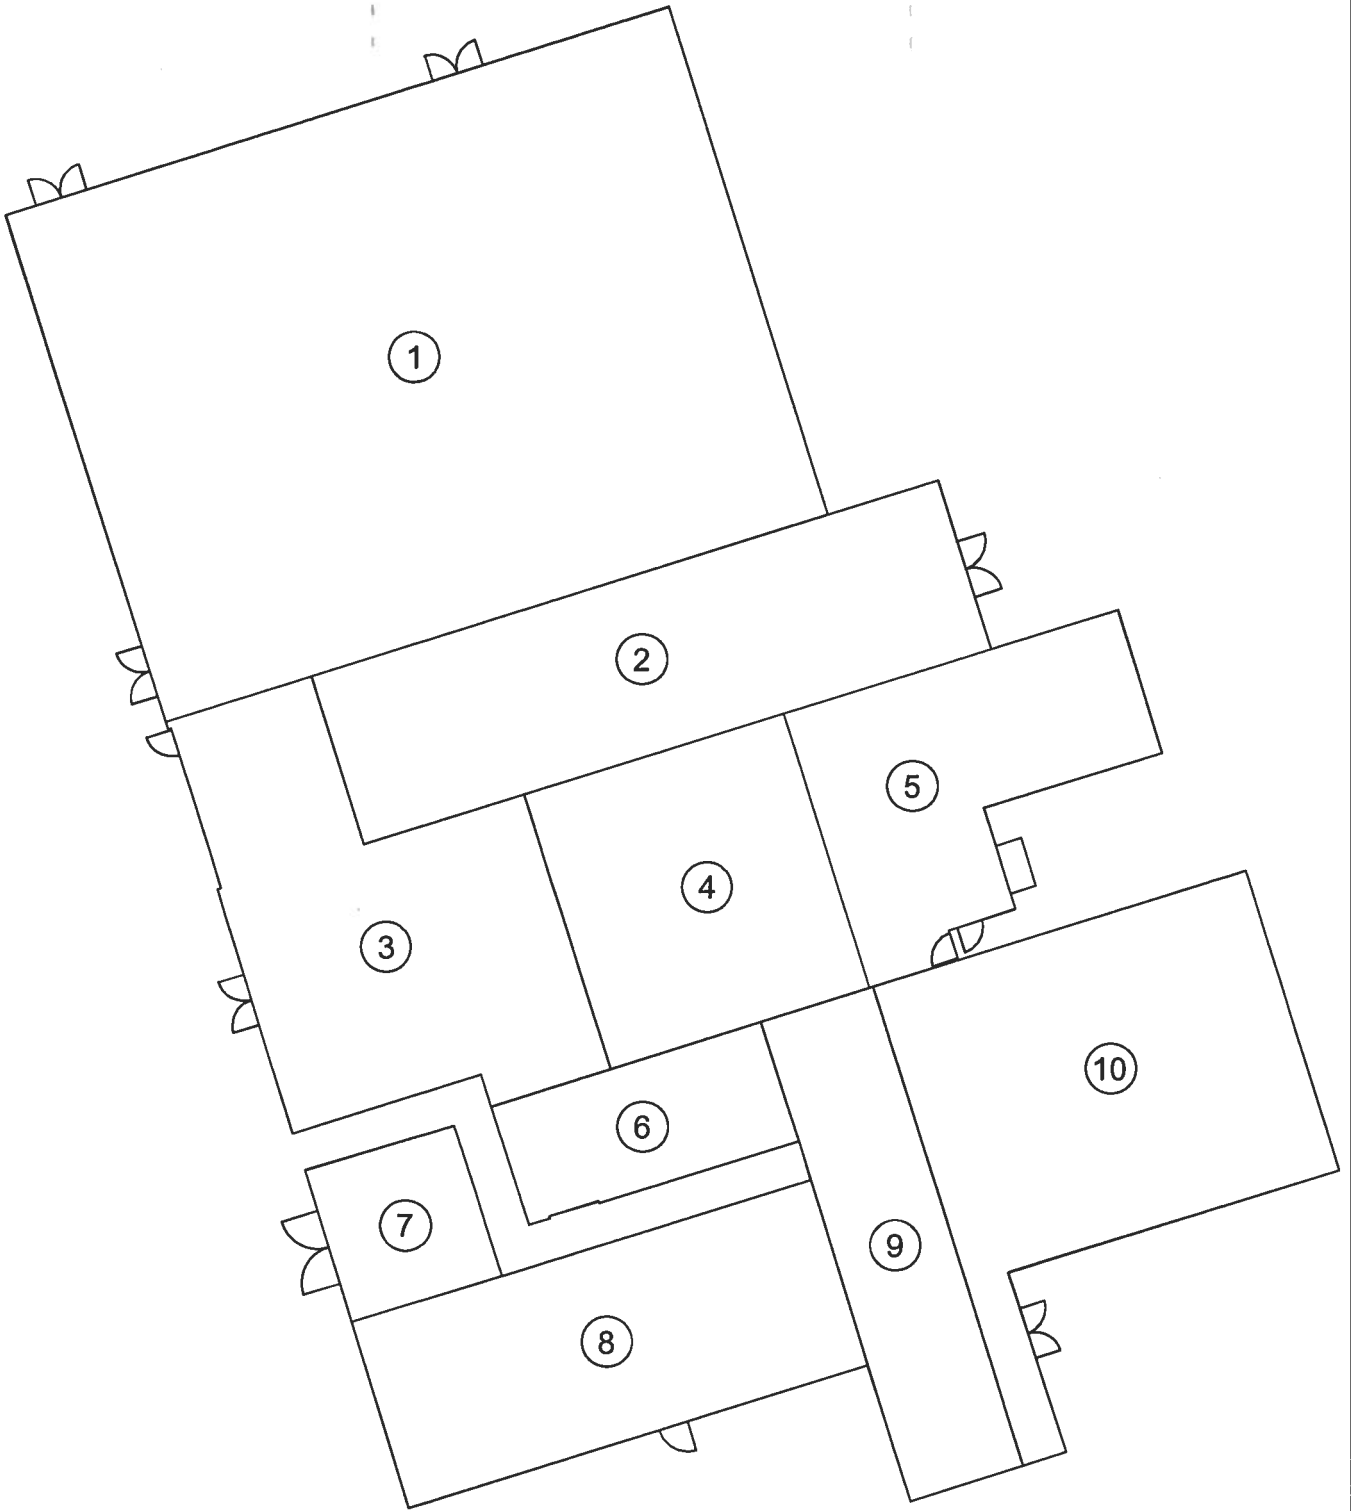
Indicative Roof Plan

Broadly we have broken down the roofs into ten separate sections as indicated on the attached annotated plan which is for reference only.

In line with the attached plan we have prepared the following table to discuss the general condition and our views in respect of the various roofs.
